Various Publications and Interpretations Joes Valley Fault Locations in Section 15 1955 - Present

CAD FILE NAME/DISK#: FIGURE GF-2

Deer Creek Mine — Mill Fork Joes Valley Fault Locations Sec. 15, T.16 S. R.6 E. Mill Fork

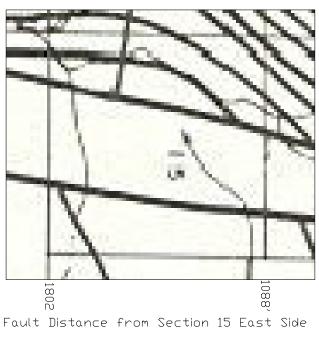
Fault Location Based on

Topography

utah: Am. Assoc. F v. 39, p. 385-481. Utahi Walton, P.T., 1955, Wasatch riuccus. M Assoc. Petroleum Geologists Bull., 1955 Fields

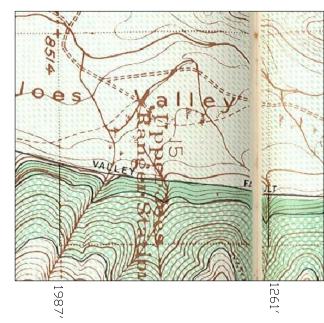
Fault Distance from Section 15 East Side

9 Mine Workings

Doelling, H.H., 1972, Central Utah Coal Fields: Sevier-Sanpete, Wasatch Plateau, Book Cliffs and Emery, Utah Geological and Mineralogical Survey, Monograph Series No. 3., p. 190-191. 1972

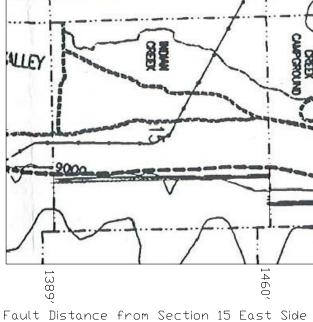
USDA Forest Service, Region 4, Manti-La Sal National Forest, Ferron-Price Ranger District, 1997, Environmental Assessment, Lease-By-Application No. Figure 2, Mill Fork Lease Tract

Fault Location Based

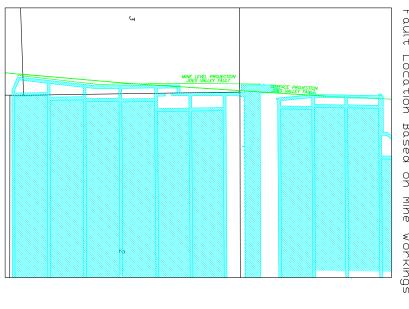
Fault Location Based

C/015/018, Energy West Mining Co., 2001, Deer Creek Mine Mill Fork Lease ML-48528 Permit No. Geologic Formations Map Section R645-301-600 Geology, MFU1823D

Andalex Mining Co., 1997 – Mine Mine Workings Map

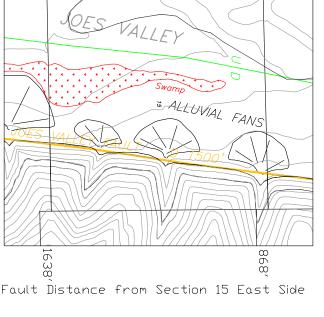
Fault Location Based on Topography

From Energy West Underground Drilling Application
